STRUCTURES NOTE 491

**SIMULATED CRASH DECELERATIONS
IN A LIGHT AIRCRAFT CABIN**

S. R. Sarrailhe.

SEPTEMBER 1983

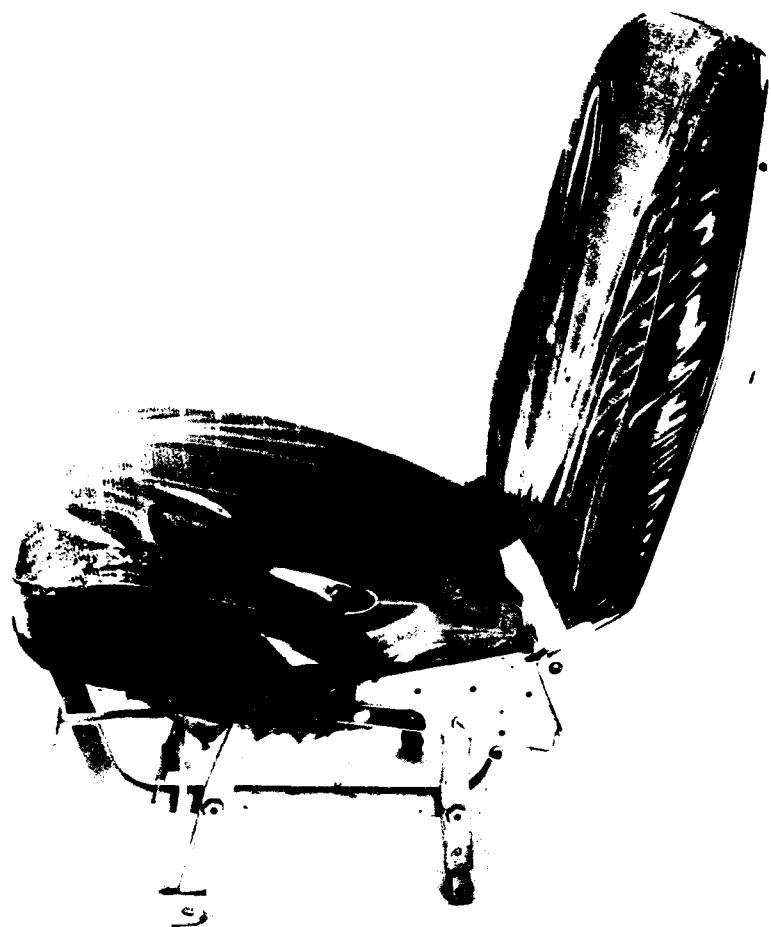
FIG. 17a SEAT 'B' AFTER TEST 15.

The peak deceleration was about 20g in each test. The deflection with the smaller dummy was only 80 mm and did not cause visible damage to the seat. The assembly is shown at the start of the deceleration and near maximum deflection on Fig. 16. The heavier dummy depressed the cushion by nearly 180 mm and the bottom of the upholstery contacted the seat frame and left several threads on the structure as shown on Figs 17a and 17b.
